# WEAR MECHANISMS AND IN-SERVICE SURFACE MODIFICATIONS OF A STELLITE 6B CO-CR ALLOY

E. Bemporad, M. Sebastiani, V. Mangione, D. De Felicis, and F. Carassiti

**Abstract:** In the present paper, the in-service wear mechanisms and cross-sectional microstructural evolution of a Stellite 6B cobalt-based alloy subjected to sliding contact conditions are analysed. The analysis is carried out using focused ion beam (FIB), transmission electron microscopy (TEM), 3D confocal profilometer and nanoindentation techniques. Samples under investigation consisted of a lip-seal adopted in a Tunnel Boring Machine (TBM). In the working conditions, the lip-seal is in sliding contact with a rubber seal in a pressurised oil environment. In those conditions, an unexpected low wear resistance was observed during service. As a consequence, a long machine downtime was necessary to replace the damaged component. Results of FIB-SEM/EDS characterisation showed severe grooving due to the presence of sand ( $\text{SiO}_2$ ) particles embedded in the rubber seal in the contact area. In addition, three body abrasive wear is observed immediately outside the contact area. Microstructural evaluation of Stellite 6 B

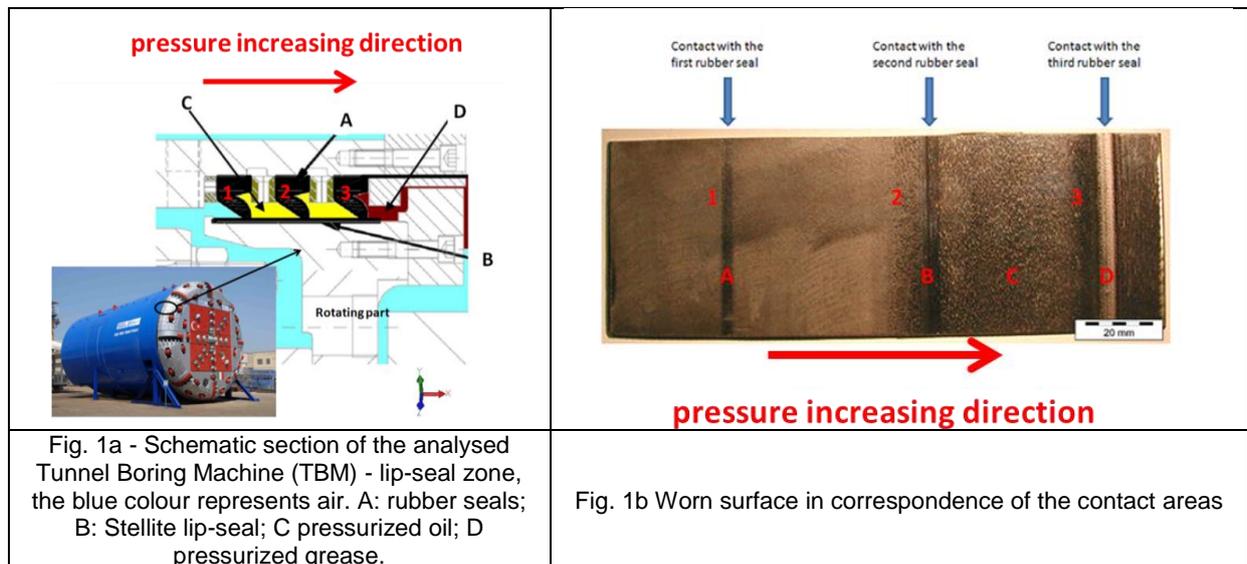
In the actual tribosystem, the lip-seal is in sliding contact with a rubber seal (a nitrile rubber with CaCO<sub>3</sub> filler) at three different points. In the correspondence of the contact points, the oil pressure is progressively increasing (see Fig. 1a, the milling head of TBM rotates around x axis, a schematic detail of the system is reported). Pressurised grease is also present to guarantee the insulation between the milling head and the leap-seal (see Fig. 1a). Nonetheless, it is likely that some SiO<sub>2</sub> particles coming from the milling process and present inside the grease could reach the contact areas.

The two samples under investigation were cut from (I) an unbent annealed plate (Stellite 6B annealed as supplied) named sample A and (II) a worn component subject to in service conditions (6 rpm at 50°C) for 8000 h named sample B and showed in Fig. 1b.

The wear rate corresponding to the deeper track (track 3 in Fig.1b) was evaluated by the Archard's law [18], assuming the main contact pressure to be equal to the yield strength of the rubber seals (7 MPa) and a sliding distance of about  $3 \cdot 10^7$  m. This value is significantly higher than other values that can be found in the literature for similar materials and testing conditions [4-7].

It is worth noting that the morphology of the worn surfaces is completely different in the three contact areas.,[20]. This can be related with the different oil and grease pressure existing between the seals and with the amount and dimension of the abrasive particles, these coming from the environment during the digging operation of the machine. This abrading media (i.e. oil or grease and solid particles), caused severe plastic deformation along the direction of sliding (Fig. 3c and 3d). In particular, the deepest wear track can be found in correspondence of the third rubber seal (labelled 3 in Fig.1b) close to the area with the highest pressure, where the presence of abrasive particles (revealed as SiO<sub>2</sub> form EDS analysis) is more probable. An extensive abrasive wear is observed outside the contact area (see Fig. 1b, on the left of wear track 3).

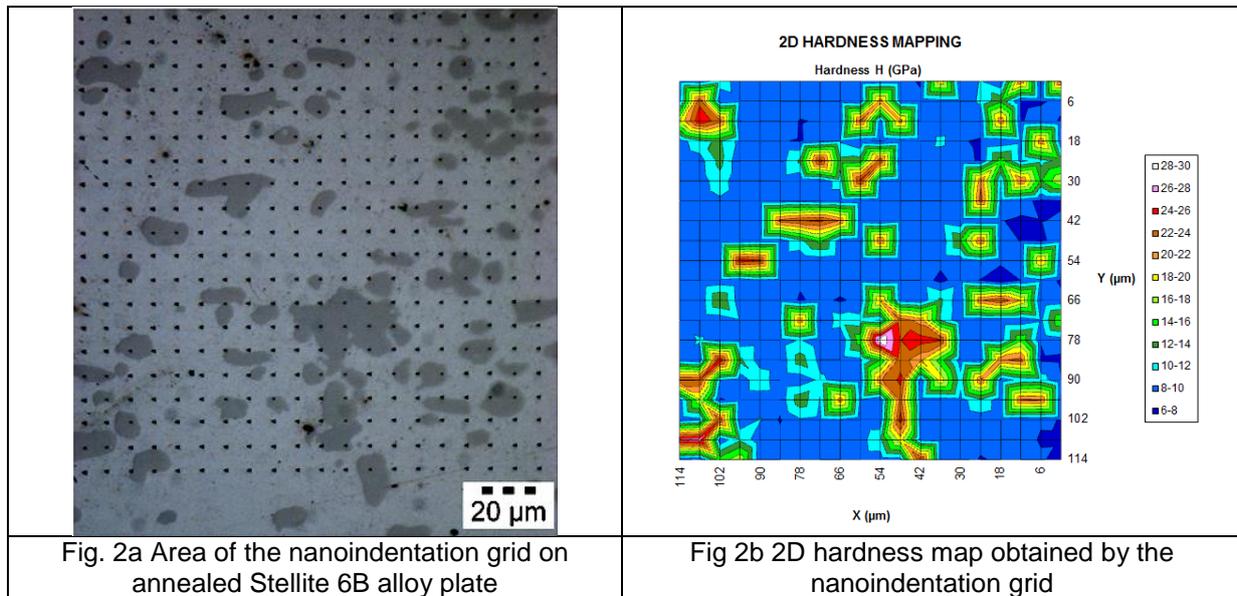
The microstructure of the Stellite alloy under investigation (as-received, i.e. not processed by bending and finishing) is reported in Fig. 2a. There, the presence of coarse chromium carbides in a cobalt matrix is observed and the nanoindentation grid is recognisable. Figure 2b shows the corresponding 2D hardness map.

A good agreement was found between the two images (Figs. 2a and 2b), clearly confirming the difference in terms of hardness that exists between the two phases.

As showed in Table I, the hardness of the carbide phase was found to be of the order of  $24.3 \pm 0,28$  GPa, while a value of about  $8.7 \pm 0,35$  GPa was found for the Co-based metal matrix. However, it can be clearly noticed that the composite material also shows regions of measured hardness down to 6 GPa.

A final point to be discussed is the reliability of nanoindentation test data and some further information that can be derived from the hardness map. The presence of edge effects is clearly visible in Figure 2b: an increment of hardness of the matrix is present in the proximity of carbide grains (green and light blue in the contour plot). These effects can be explained respectively with the severe work hardening of the Co phase nearby the carbides, as confirmed by FIB analyses.

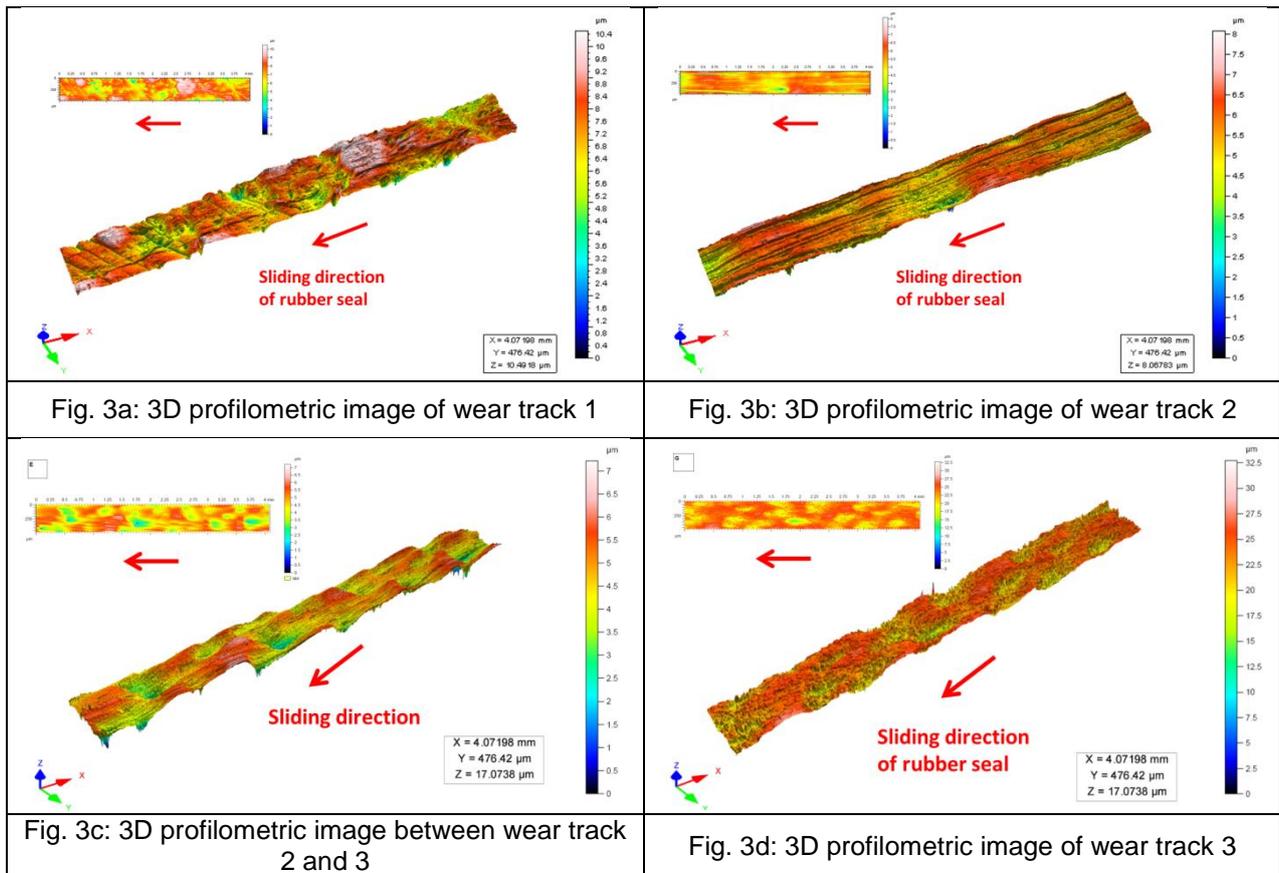
Severe grooving abrasions are visible in the area of contact (Figure 3d), and in its vicinity (Figure 3c). The grooving is probably due to the abrading particles embedded in the rubber seal.

In the wear tracks 1 and 2 there are not evident plastic deformations, while some grooves are present along the sliding direction, due to the presence of fewer or smaller particles of SiO<sub>2</sub>.

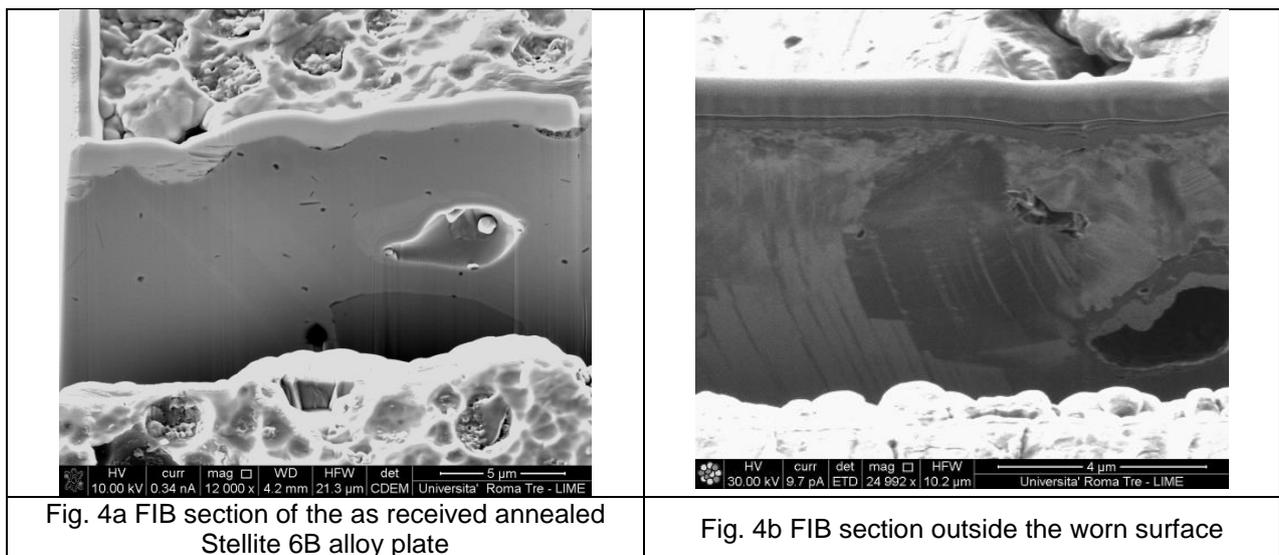
Figure 4a shows FIB sections of sample A, presenting a coarse grains microstructure with no hardened layer.

On the other hand, a 2 μm thick surface hardened layer is clearly visible in sample B, even if it is far from the worn surfaces (on the left of wear track 1, see Fig. 1b), (Figure 4b). This is probably due to the shaping (i.e. rolling) and grinding processes, which changes considerably the surface microstructure and its tribo-mechanical behaviour.

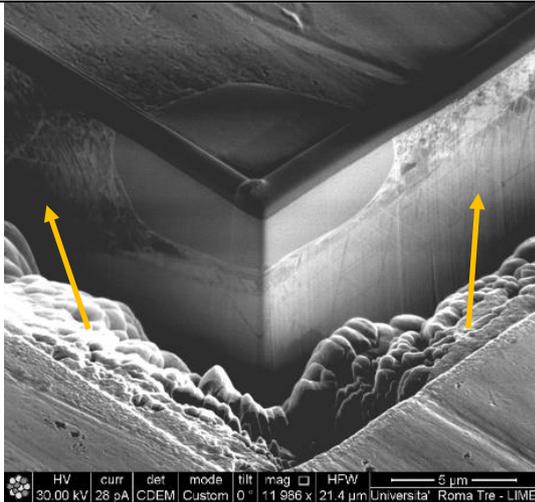
Microstructural evaluations of the cross-section performed by FIB on worn surfaces are reported in Figures 5a-b (outside the contact area between track 3 and 2) and Figures 6a-d (inside the contact area, i.e. inside the track 3), where significant surface modifications and the formation of a tribolayer are observed at the specimen surface, especially near the carbide/matrix interfaces.

In particular, a ca. 2µm deep hardened micro/nano-crystalline layer is formed in the matrix at the very surface, while a significant amount of stacking faults and shear bands (highlighted by arrows in figs. 5a-b) is observed in the subsurface layers.

It is important to note that the average depth of wear track 3 was greater than 1 mm, and this demonstrates that the hardened layer cannot be due to the preliminary grinding process but it is essentially due to severe plastic deformation during in-service wear.

Fig. 5a FIB section of the worn surface outside the contact area (arrows indicate the hardened layer)

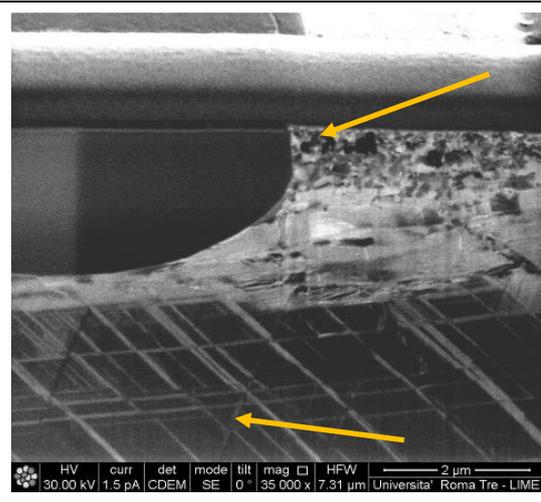
Fig. 5b FIB section of the worn surface outside the contact area – detail (arrows indicate the hardened layer and stacking faults)

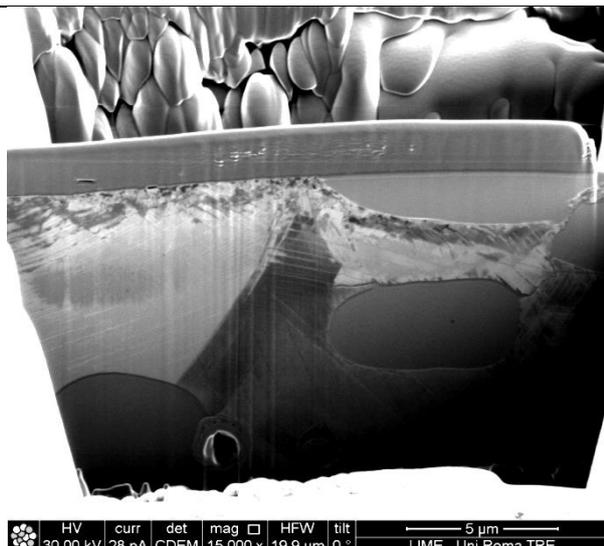
It is also worth mentioning that similar deformation mechanisms are observed both inside (Figures 6a-b) and outside (Figures 5a-b) the contact area, suggesting that the hardened layer is given by the action of the abrading particles coming from the operation of the machine while digging.

Fig. 6a FIB section of the worn surface inside the contact area

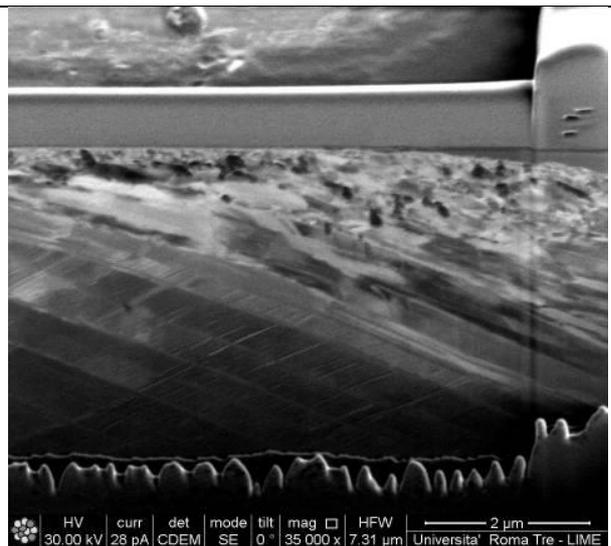
Fig. 6b FIB section of the worn surface inside the contact area – detail

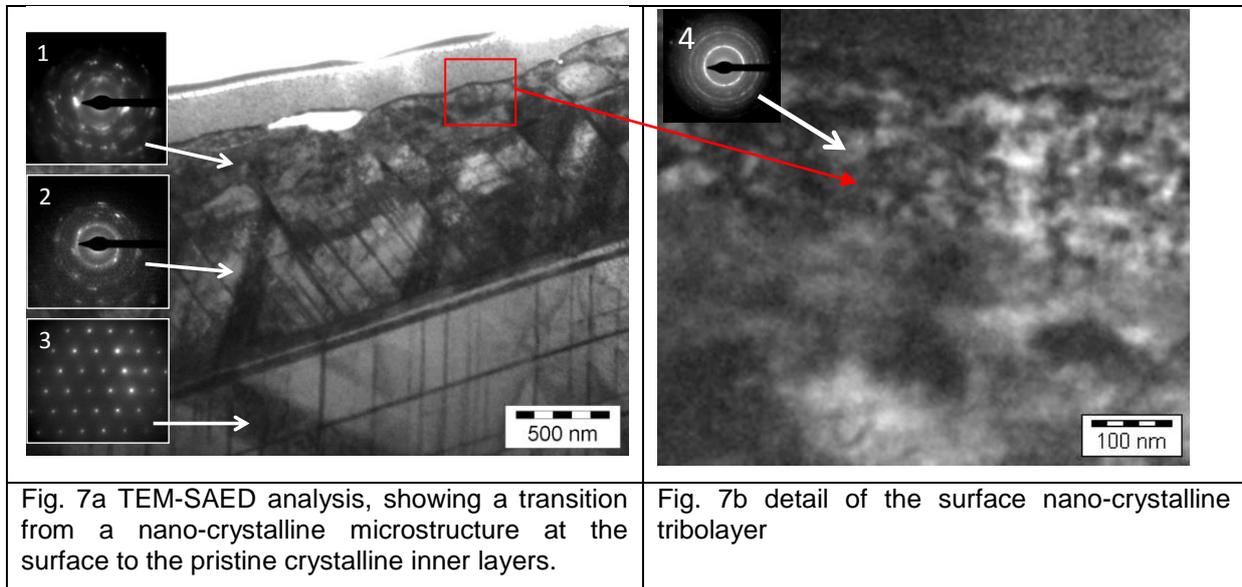
A more detailed TEM-SAED analysis of the worn surface is reported in Figure 7a-b, where three different areas are identified in the plastically deformed zone: (1) a nano-crystalline 100 nm thick layer at the very surface, (2) a 300 nm micro-crystalline layer with a significant presence of shear bands

and (3) a crystalline layer where the deformation effects only consist of shear bands of stacking faults. A complete re-crystallization during plastic deformation is observed in zones (1) and (2), as it is clearly visible in Figure 7b, where a detail of the nano-crystalline surface layer and related SAED pattern are reported.

Fig. 7a TEM-SAED analysis, showing a transition from a nano-crystalline microstructure at the surface to the pristine crystalline inner layers.

Fig. 7b detail of the surface nano-crystalline tribolayer

The microstructural cross-section analysis of worn surfaces clearly showed that complex surface modifications occurred during wear. In particular, the formation of a thin nano-crystalline hardened layer was observed at the specimen surface. FIB-SEM and EDS analyses (not reported in this paper) also showed the presence of an iron-rich tribolayer on the carbide grains and SiO<sub>2</sub> contaminants embedded in the Co-rich matrix. Plastic deformation was shown by profilometric analysis, especially in the area with higher contact pressure, where the hardened layer is also characterized by stacking fault formation. A clear and stepwise transition from a nano-crystalline microstructure to the pristine crystalline one was observed from the surface down to the inner layers (Figures 7a-b).

In perspective, a much more effective solution could be obtained by the adoption of nano-structured multiphase hard-facing alloys. As an example, a WC-Co nanostructured HVOF coating [18-19] could be a more suitable solution for this specific situation. In fact, under these specific in-service environmental conditions, a high proportion of WC is usually present and a very fine dispersion of the hard particle is achieved by nanostructuring. Another possible solution could be the use of the laser cladding coating technique [2,7], which is commonly adopted to obtain thick films of a variety of hard materials, including Co alloys. The adoption of a thick coating seems to be a suitable solution in view of the improvement of performances of such large-scale components, also because it could allow the use of a cheaper and relatively more workable substrate (e.g. steel) and a more accurate optimization of the surface microstructure.
